Manhole Inspection Summary

Manhole # S13MM1007MH

Insp Date: **12/6/06 11:11 AM**

Location Address: **3010 ROSALIND AVE**

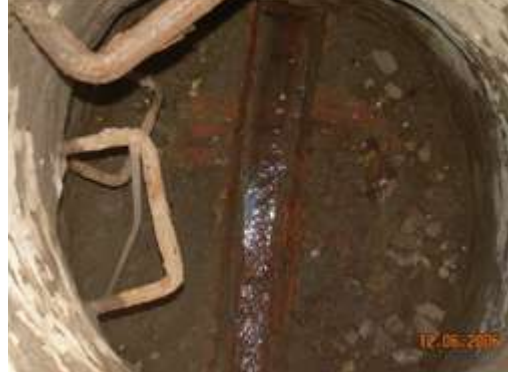
Top View

Evidence of surcharge - Bench debris.
Corroded steps.

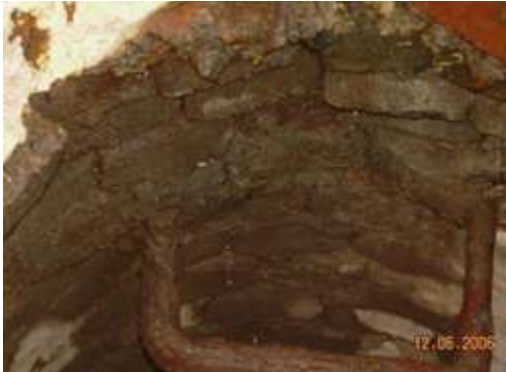
Defect

Condition: ☐ Sound ☐ Cracked ☐ Root Intrusion ☐ Loose Brick ☒ **Deteriorated**

Infiltration: ☐ None ☒ **Joint** ☐ Cracks ☒ **Mortar** ☐ Roots ☐ Wall

Infiltration: ☐ None ☐ Joint ☐ Cracks ☒ **Mortar** ☐ Roots ☒ **Wall**

Adjustment and Corbel deterioration and infiltration. Corroded steps.

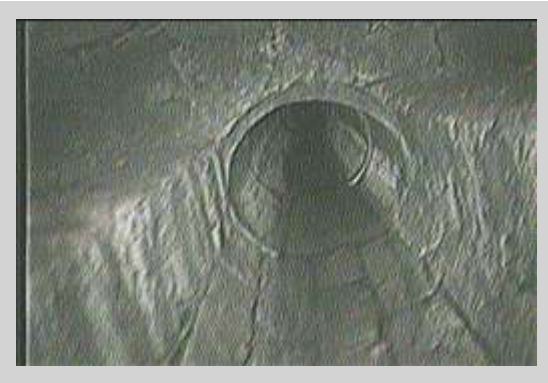
Pipe Out @ 12 O'Clock

Barrel deterioration and infiltration. Channel deterioration.

Deposits: ☐ None ☐ Mud ☐ Sludge ☐ Debris ☒ **Grease**

Infiltration: **Evidence** Pipe Seal Cond: **Cracked**

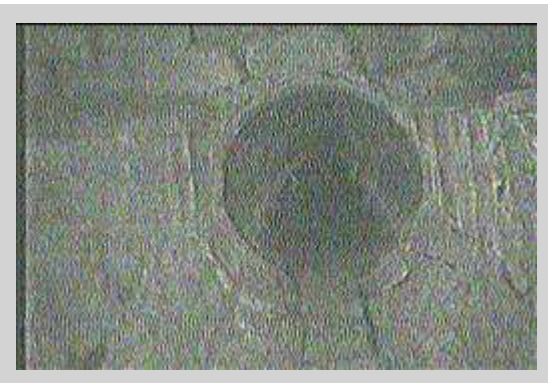
Pipe In @ 6 O'Clock

Deposits: ☐ None ☐ Mud ☐ Sludge ☐ Debris ☒ **Grease**

Infiltration: **Evidence** Pipe Seal Cond: **Cracked**
